WOOD DESTROYING PESTS AND ORGANISMS INSPECTION REPORT

Building No. 1736	Street Lindo Street	City Benicia	Zip 94510	Date of Inspection September 16, 2021	Number of Pages 4
Sheppard Termite Services 707-208-2102 or 707-452-0422 PR#4624 SheppardTermite@sbcglobal.net				Company Report # R8732	
Ordered By: Windy Rodriguez Plata Realty		Property Owner and/or Party of Interest: DocuSigned by:

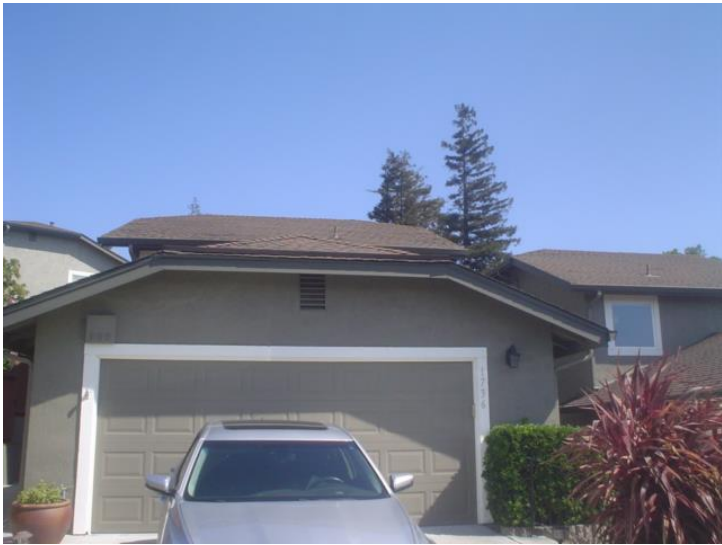
NOTE: DIAGRAMS ARE NOT TO SCALE

1 Finding: Fungi (wood-rot) damage found in the base of garage door jamb. Indicated on the diagram by “1”, and some areas shown in Fig.1 images on the back pages of this report.

2 Finding: Fungi (wood-rot) damage found in the exterior trim. Indicated on the diagram by “2”, and some areas shown in Fig.2 images on the back pages of this report.

Recommendation: Repair/replace fungi damaged wood members as needed.

Recommendation: Replace damaged trim as needed.
