WOOD DESTROYING PESTS AND ORGANISMS INSPECTION REPORT

Building No. 538	Street Thomas Circle	City Suisun City	Zip 94585	Date of Inspection December 21, 2021	Number of Pages 3
---------------------	-------------------------	---------------------	--------------	--	----------------------

General Description: Single story home on concrete slab with attached garage.	Inspection Tag Posted: Garage
	Other Tags Posted:

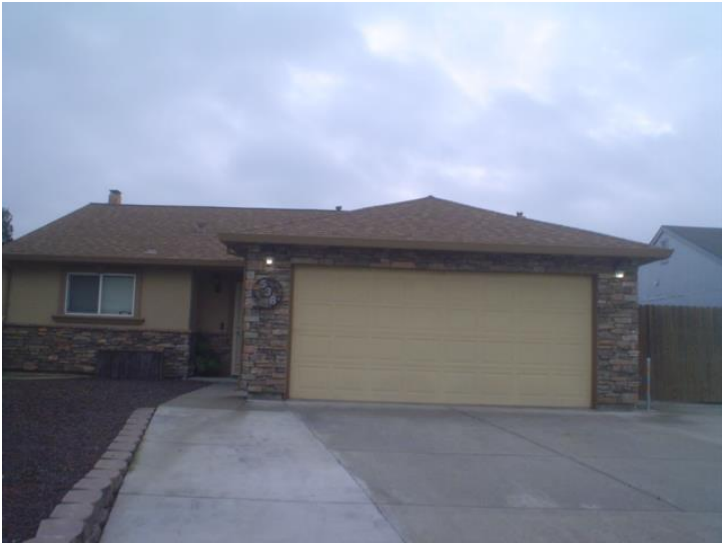
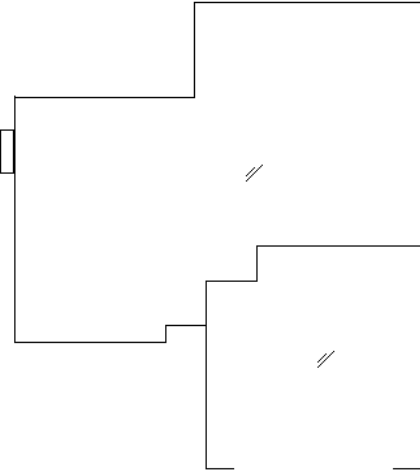
<p>NOTE: DIAGRAMS ARE NOT TO SCALE</p>

An inspection has been made of the structure(s) shown on the diagram in accordance with the Structural Pest Control Act. Detached porches, detached steps, detached decks and any other structures not on the diagram were not inspected.
