# WOOD DESTROYING PESTS AND ORGANISMS INSPECTION REPORT

BUILDING NO. <b>4534</b>	STREET, CITY, STATE, ZIP <b>Dartmouth Drive, Sacramento CA 95841</b>	Date of Inspection <b>6/4/2025</b>	No. of Pages <b>5</b>
-----------------------------	---	---------------------------------------	--------------------------

General Description: This property consists of a one story single family residence with stucco, wood and brick exterior and composition shingle roof covering.	Inspection Tag Posted: Garage
	Other Tags Posted: Terminix and Western Exterminators, 2013, hard to read the tags

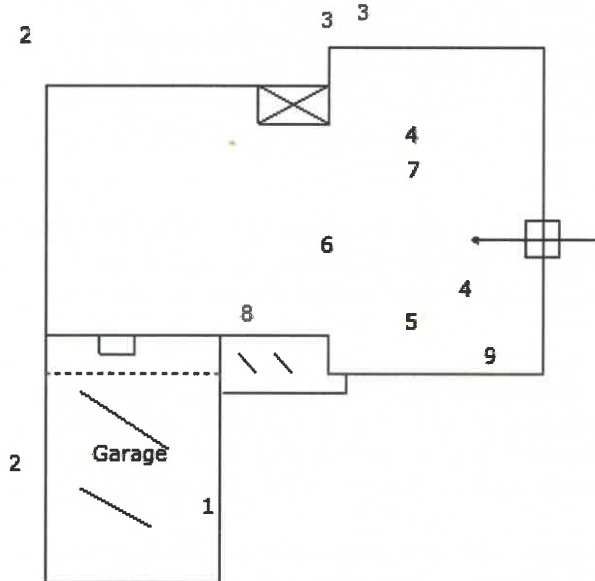
An inspection has been made to the structure(s) shown on the diagram in accordance with the Structural Pest Control Act. Detached porches, detached steps, detached decks and any other structures not on the diagram were not inspected.

- ITEM 1 FINDING: Fungus dry rot damage noted to portions of 2x4 wall studs, mudsill and 1x8 sheathing at side wall of garage under corner of window.
- RECOMMENDATION: Trim out approximately 1 inch of damaged wood members and treat wood members with professional fungicide Timbor or other approved fungicide. Apply caulking to window frame to stop apparent leak.

- ITEM 2 FINDING: Fungus dry rot damage noted to the corners of barge rafter and fascia board of the roof overhang.
- RECOMMENDATION: Remove the roof covering as needed to expose the damaged areas. Remove damaged wood members and replace with new material. Install roof covering to the exposed areas only. NOTE: Guarantee applies to the roof covering at the repaired areas only.

- ITEM 3 FINDING: Fungus dry rot damage noted to the 1x8 VR roof sheathing & 2X6 rafter above electrical meter at roof overhang.
- RECOMMENDATION: Remove the roof covering as needed to expose the damaged areas. Remove damaged wood members and replace with new material. Install roof covering to the exposed areas only. NOTE: Guarantee applies to the roof covering at the repaired areas only.

- ITEM 4 FINDING: Fungus dry rot damage noted to the plywood of the roof structure visible in the attic at front and rear. Roof coverings in these areas were buckled and apparently leak.
