# Twin Termite and Pest Control

**Statement Date:** 04/20/2021  
**Report #:** 70018  
**Service Address:** 692 East L Street, Benicia, CA 94510  
**Escrow #:**  
**Closing Date:** 11/30/-0001

Building No: 692	Street : East L Street	City : Benicia	Zip : 94510	Inspection Date : 04/19/2021	Page : 1/7
---------------------	---------------------------	-------------------	----------------	---------------------------------	---------------

**WHAT IS A WOOD DESTROYING PEST & ORGANISM INSPECTION REPORT? READ THIS DOCUMENT. IT EXPLAINS THE SCOPE AND LIMITATIONS OF A STRUCTURAL PEST CONTROL INSPECTION AND A WOOD DESTROYING PEST & ORGANISM INSPECTION REPORT.**

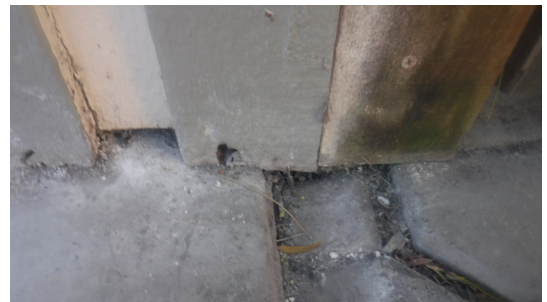
**3A:**

3A. FINDING: THERE IS WOOD DECAY FUNGI (DRY ROT) DAMAGE AT THE 1X4 TRIM .

RECOMMENDATION: REMOVE ALL DAMAGED WOOD AND REPLACE WITH NEW MATERIAL. APPLY TIMBOR (ACTIVE INGREDIENT, DISODIUM OCTABORATE TETRAHYDRATE) TO THE ADJACENT INFECTED AREAS AS NECESSARY FOR THE CONTROL OF WOOD DECAY FUNGI (DRY ROT).

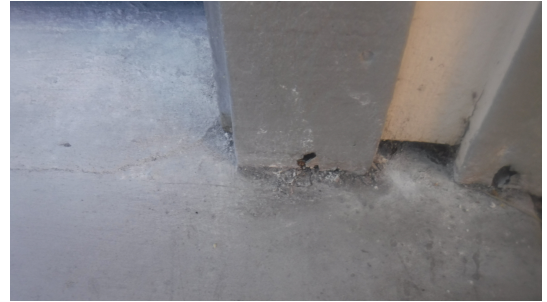
**3B:**

3B. FINDING: THERE IS WOOD DECAY FUNGI (DRY ROT) DAMAGE AT THE 1X4 GARAGE DOOR TRIM .

RECOMMENDATION: REMOVE ALL DAMAGED WOOD AND REPLACE WITH NEW MATERIAL. APPLY TIMBOR (ACTIVE INGREDIENT, DISODIUM OCTABORATE TETRAHYDRATE) TO THE ADJACENT INFECTED AREAS AS NECESSARY FOR THE CONTROL OF WOOD DECAY FUNGI (DRY ROT).

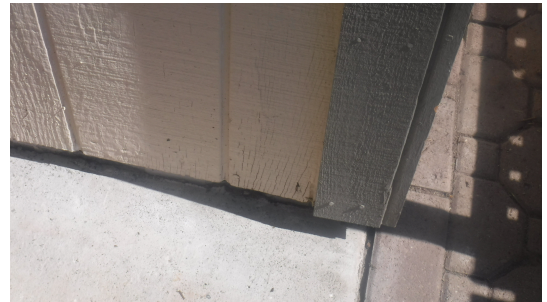
**3C:**

3C. FINDING: THERE IS WOOD DECAY FUNGI (DRY ROT) DAMAGE AT THE T1-11 SIDING AND TRIM.

RECOMMENDATION: REMOVE TRIM IF NECESSARY. REMOVE AND REPLACE THE DAMAGED PORTIONS OF SIDING USING GALVANIZED Z-BAR WHERE PRACTICAL. REMOVE AND REPLACE COMPLETE SHEETS WHERE NECESSARY (TO MATCH AS CLOSE AS SUPPLIES PERMIT) AND INSTALL NEW TRIM TO REPAIRED AREAS WHERE NEEDED. APPLY TIMBOR (ACTIVE INGREDIENT: SODIUM OCTOBORATE) ADJACENT TO THE INFECTED AREAS FOR THE CONTROL OF WOOD DECAY FUNGI AS NECESSARY.
