Report #: 89001

WOOD DESTROYING PESTS AND ORGANISMS INSPECTION REPORT

Building No 1222	Street Swan Lake Drive	City Fairfield	Zip 94533	Date of Inspection 12/20/2023	Number of Pages 8
---------------------	---------------------------	-------------------	--------------	----------------------------------	----------------------

General Description: THIS PROPERTY CONSISTS OF A TWO STORY RESIDENCE WITH STUCCO SIDING	Inspection Tag Posted: GARAGE
	Other Tags Posted: NONE

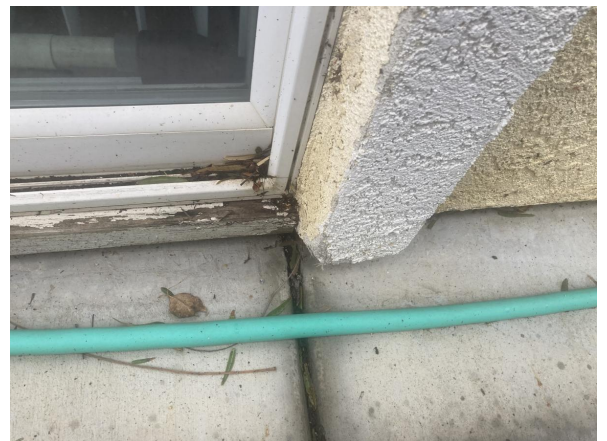
3A:

3A. FINDING:

THERE IS WOOD DECAY FUNGI (DRY ROT) DAMAGE AT THE KICK TRIM .

REMOVE ALL DAMAGED WOOD AND REPLACE WITH NEW MATERIAL. APPLY TIMBOR (ACTIVE INGREDIENT, DISODIUM OCTABORATE TETRAHYDRATE) TO THE ADJACENT INFECTED AREAS AS NECESSARY FOR THE CONTROL OF WOOD DECAY FUNGI (DRY ROT).

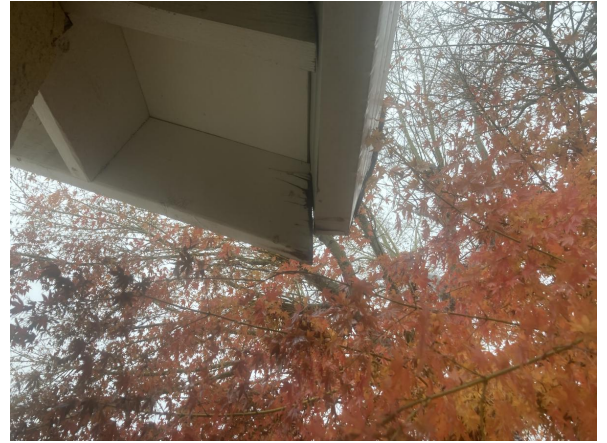
**3B:**

3B. FINDING:

THERE IS WOOD DECAY FUNGI (DRY ROT) DAMAGE AT THE BARGE RAFTER .

REMOVE ALL DAMAGED WOOD AND REPLACE WITH NEW MATERIAL. APPLY TIMBOR (ACTIVE INGREDIENT, DISODIUM OCTABORATE TETRAHYDRATE) TO THE ADJACENT INFECTED AREAS AS NECESSARY FOR THE CONTROL OF WOOD DECAY FUNGI (DRY ROT).

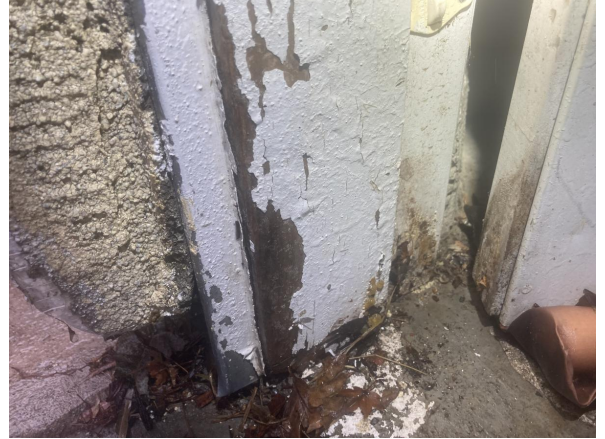
**3C:**

3C. FINDING:

WOOD DECAY FUNGI (DRY ROT) HAS DAMAGED THE SIDE GARAGE DOOR AND JAMBS.

REMOVE AND DISPOSE OF THE DAMAGED DOOR AND JAMBS. APPLY TIMBOR (ACTIVE INGREDIENT: SODIUM OCTOBORATE) ADJACENT TO THE INFECTED AREAS FOR THE CONTROL OF WOOD DECAY FUNGI AS NECESSARY. INSTALL A NEW PREHUNG DOOR ACCORDING TO CURRENT BUILDING CODES. OUR ESTIMATE INCLUDES INSTALLATION OF INTERIOR AND EXTERIOR TRIM.
