Twin Termite and Pest Control

Report #: 70425

Service Address: 161 Florence Court, Vallejo, CA 94589

WHAT IS A WOOD DESTROYING PEST & ORGANISM INSPECTION REPORT? READ THIS DOCUMENT. IT EXPLAINS THE SCOPE AND LIMITATIONS OF A STRUCTURAL PEST CONTROL INSPECTION AND A WOOD DESTROYING PEST & ORGANISM INSPECTION REPORT.

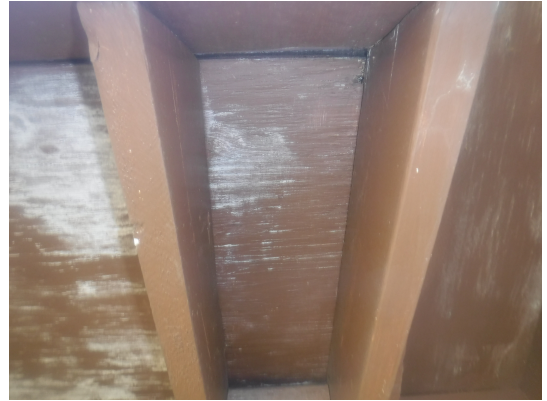
3A:

3A. FINDING: THERE IS EVIDENCE OF WOOD DECAY FUNGI (DRY ROT) DAMAGE AT THE PLYWOOD OF THE ROOF OVERHANG.

RECOMMENDATION: REMOVE THE ROOF COVERING TO EXPOSE THE DAMAGED AREAS IF NECESSARY. REMOVE ALL STRUCTURALLY DAMAGED WOOD MEMBERS AND REPLACE WITH NEW MATERIAL. APPLY TIMBOR (ACTIVE INGREDIENT, DISODIUM OCTABORATE TETRAHYDRATE) ADJACENT TO THE INFECTED AREAS FOR THE CONTROL OF WOOD DECAY FUNGI AS NECESSARY. INSTALL ROOF COVERING TO THE EXPOSED AREAS ONLY. GUARANTEE APPLIES TO ROOF COVERING IN REPAIRED AREAS ONLY.

NOTES: DURING THE COURSE OF REPAIRS, IF ADDITIONAL LAYERS OF ROOFING AND/OR ROOF SHEATHING ARE DISCOVERED AT THE EXPOSED AREA, THEN THE HOMEOWNER WILL BE CONTACTED AND A SUPPLEMENTAL REPORT ISSUED REFLECTING ADDITIONAL FINDINGS/COSTS.

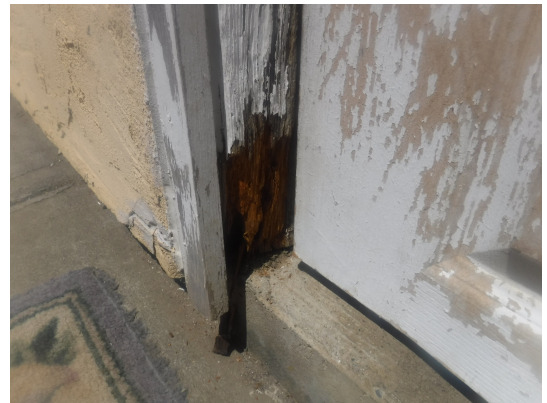
3B:

3B. FINDING:

THERE IS WOOD DECAY FUNGI (DRY ROT) DAMAGE AT THE GARAGE PEDESTRIAN DOOR JAMB .

RECOMMENDATION:

REMOVE THE DAMAGED PORTION OF WOOD AND REPLACE WITH NEW MATERIAL. APPLY TIMBOR (ACTIVE INGREDIENT, DISODIUM OCTABORATE TETRAHYDRATE) TO THE ADJACENT INFECTED AREAS AS NECESSARY FOR THE CONTROL OF WOOD DECAY FUNGI (DRY ROT).
