ROOF REPORT AND ESTIMATE
Estimate # : E218569
Inspection Date : 08/11/2021

285 Larkspur Drive,, Vacaville, California, 95687.

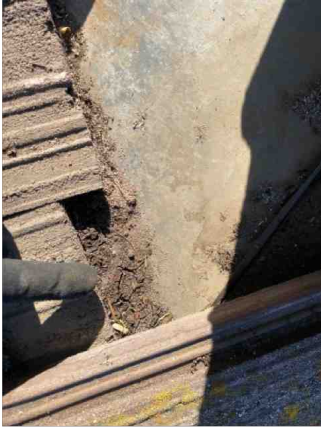
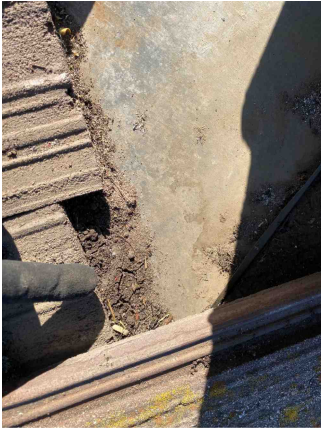
Inspection Pictures

Findings	
CONCRETE TILE ROOF SERVICE (Package)	
Service includes sealing ridge/rake/hip junctions as needed, installing new rubber collars on plumbing vent pipes & resetting up to 10 slipped tiles. Small broken corners (less than 2") at bottom edge of tiles are not a leak concern & do not need to be repaired.	
MENDING BROKEN TILE/S (Each)	
Approximately 2 broken tile/s need to be mended with tile adhesive. This does not include small bottom corner breaks under 3".	
VALLEY FLASHING CLEANOUT/S (Feet)	
Debris blockage needs to be cleaned out of 4 valley flashing/s for roughly a total 64'.	
Warranty	Amount
2-Year Roof Certification	\$ 250.00
