THIS DISCLOSURE STATEMENT CONCERNS THE REAL PROPERTY SITUATED IN THE CITY OF Concord, COUNTY OF Contra Costa, STATE OF CALIFORNIA, DESCRIBED AS 1725 Landana Dr #2, Concord, CA 94519-1447

1725 Landana Drive unit #2, Concord , CA 94519
Inspection prepared for: Patricia Ballisteri
Date of Inspection: 9/16/2022

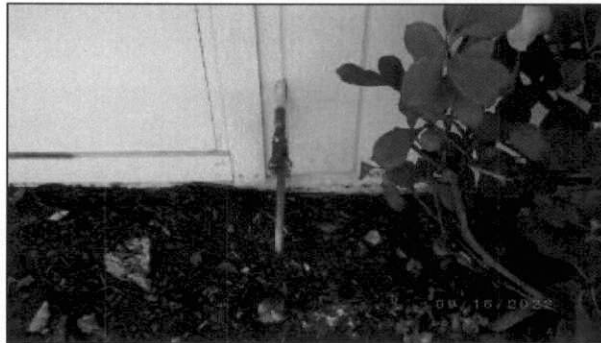
main shutoff

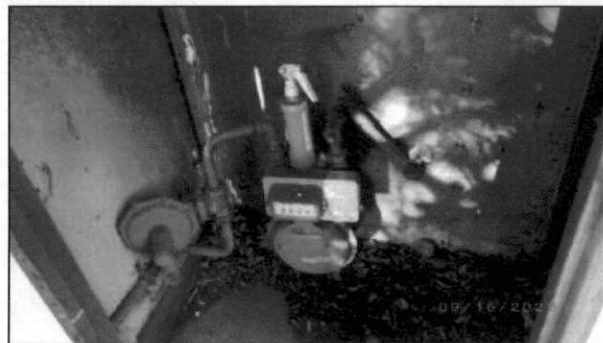
gas meter

The main house gas meter is located at the right side of the home. The main gas valve to the home is located to the left of the meter. We suggest having the proper (dedicated) wrench "zip tied" to the gas meter for easy access in the event of an emergency. These wrenches are now available at a home supply store.

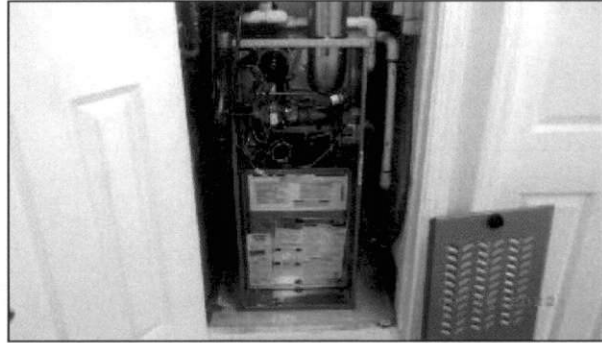
newer furnace

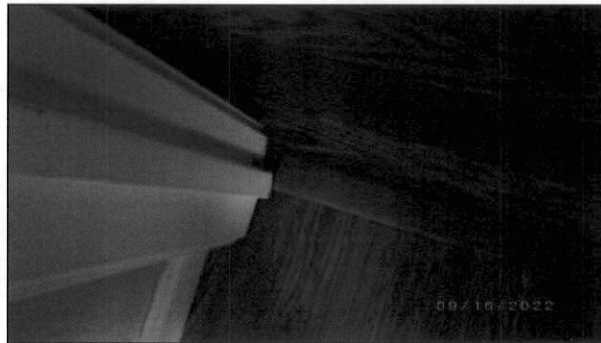
cosmetic blemishes

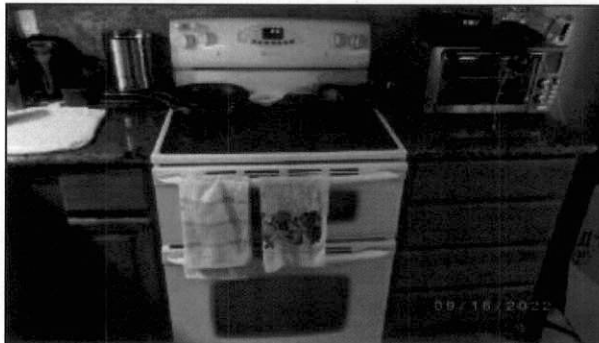
The range is in moderately worn condition. The stove was functional at the time of this inspection.

tested ok

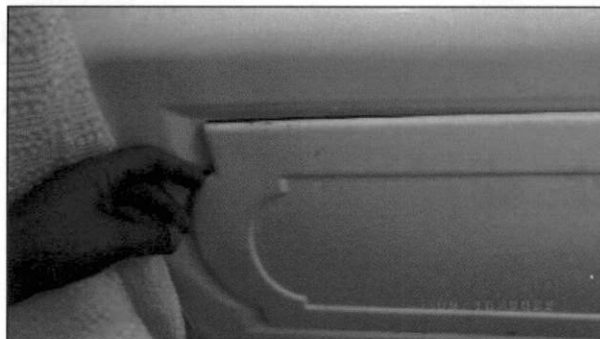
There is a spa/tub in the main bathroom. The pump, plumbing, and wiring is located below the unit and was not accessible due to the possibility of damaging the access door. We recommend providing access to this area and further inspection by a qualified inspector.

no access

can be accessed. Attached with velcro

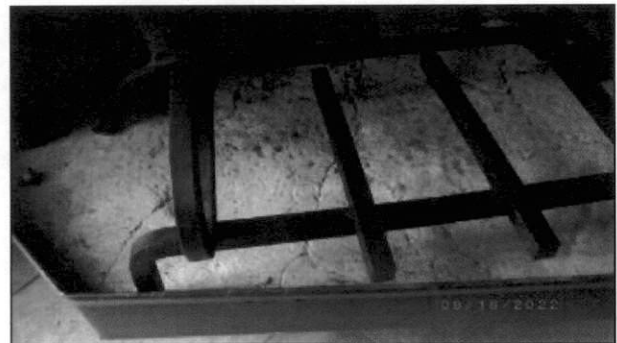
moderatley worn
